MONITORING THE FLASH CRYOMODULE TRANSPORTATION FROM DESY HAMBURG TO CEA SACLAY: COUPLER CONTACT, VACUUM, ACCELERATION AND VIBRATION ANALYSIS

Abstract

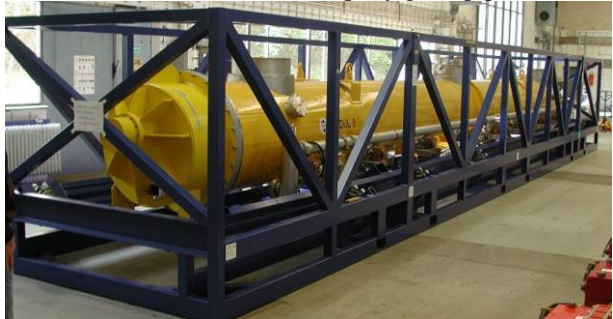
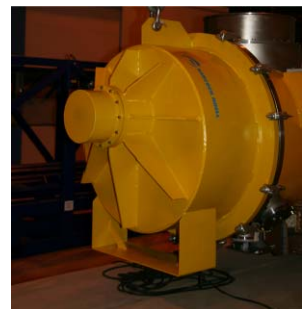
The cryomodule is supported with a metallic frame consisting of two cages, one fixed to the truck and the other damped with helical coils in a compression-roll configuration connected to the cryomodule. The coils are

designed to attenuate the shocks between the base frame and the module.

The supporting system includes two end-caps to lock the helium gas return pipe position at the end position and to avoid transversal movement of lateral supporting posts which can cause stresses in the epoxy glass pipes.

Figure 1: The damping frame, the coils and an end cap.

During the transportation the required acceleration limits were satisfied with the designed frame and end caps and no relevant shocks were observed on the module.

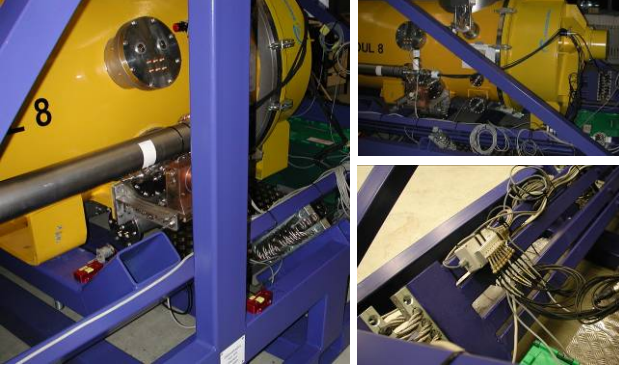
The module is equipped with the following instrumentation:

- 4 vacuum gauges: 2 monitoring the vacuum level in the coupler line (static vacuum), 2 for the beam line vacuum (cavities travel in static vacuum condition);
- a circuit to monitor coupler antenna shorts;
- 2 independent systems of accelerometers: Monilog and Sensr GP1 sensors (each system with a sensor on the fixed frame and one on the damped one);
- 4 geophones: 3 already installed inside the module (one on the center cavity, 2 on the magnet) and one on the damped frame. The geophones are equipped with a feedback circuit to extend the low frequency (1-10 Hz) acceleration mechanical range from 0.15 to more than 4 g peak-to-peak [1].

Figure 2: The installed instrumentation.

The data measured by the gauges, the coupler circuit outputs and the geophones were recorded through a stand alone data logger with a sampling rate of 180 sample/s, allowing a good quality Fourier analysis.
